The Swiftcurrent Bridge Replacement; Glacier National Park

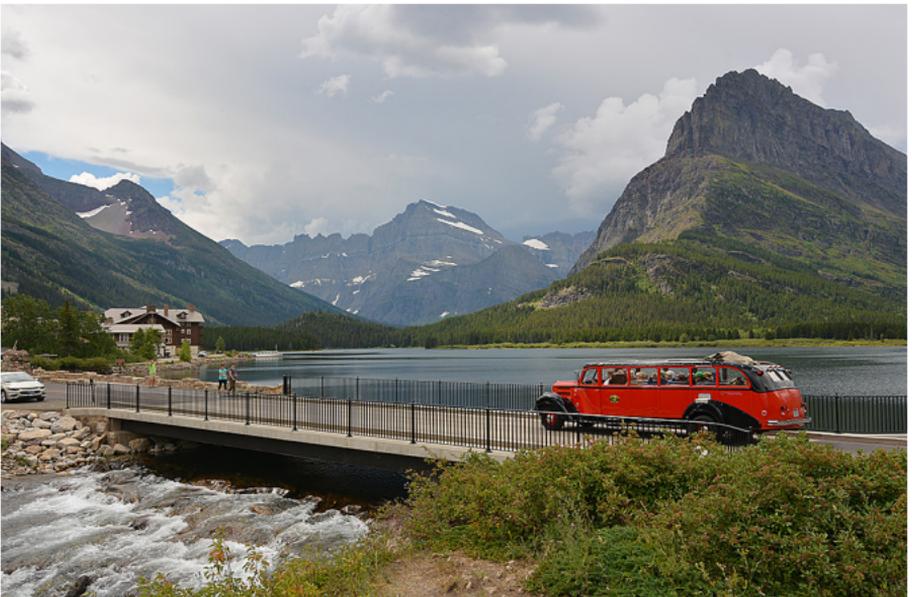
The Swiftcurrent Bridge following reconstruction (taken on July 26, 2016). Many elements of the new bridge design mimic those of the historic bridge. (NPS photo by Gary MacFadden)

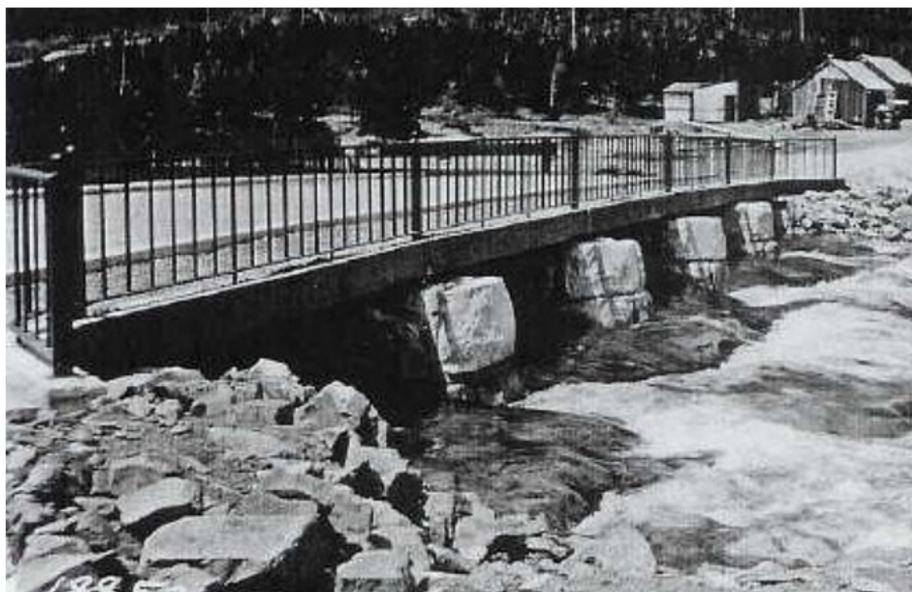
The historic Swiftcurrent Bridge in 1930. Note the four stone piers, which were deleted in the new design. (NPS photo.)

The completed structure reflected the NPS design philosophy of the period and blended well within the spectacular surroundings. The thin deck and metal railing lessened the bridge's potential appearance as being a dam at the lake outlet. The 75-foot long, five-span concrete deck bridge included four stone piers and two stone abutments.

Only two major improvements were made to the bridge over the years: in 1942, due to erosion from ice, the bridge's piers were reinforced with steel pins, a concrete veneer, and protective steel shields. And in 1958, the deck was paved and new concrete was laid over the walkway.

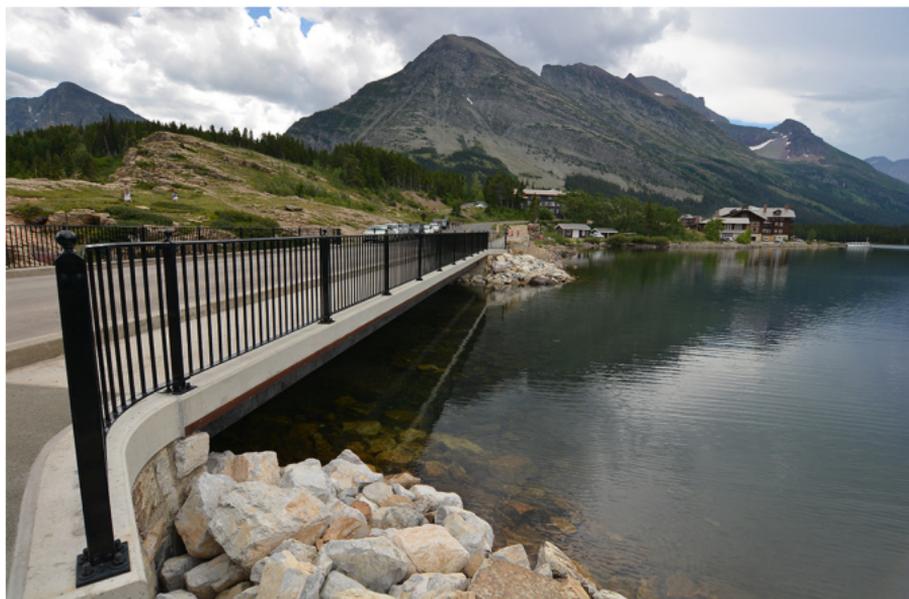
The reconstructed Swiftcurrent Bridge showing the new railing and the pedestrian walkway. (NPS photo by Gary MacFadden)

The design for the new bridge deck matches the historic bridge width of 28 feet 8 inches. This width accommodates two 9-foot travel lanes, a 3-foot wide sidewalk, and a 5-foot wide bridle path, the same layout as the original bridge. The sidewalk and bridle path are separated from vehicle traffic with curbing. The new railings are of a similar design to the historic railings, but with modifications to height and baluster spacing to meet current safety codes.

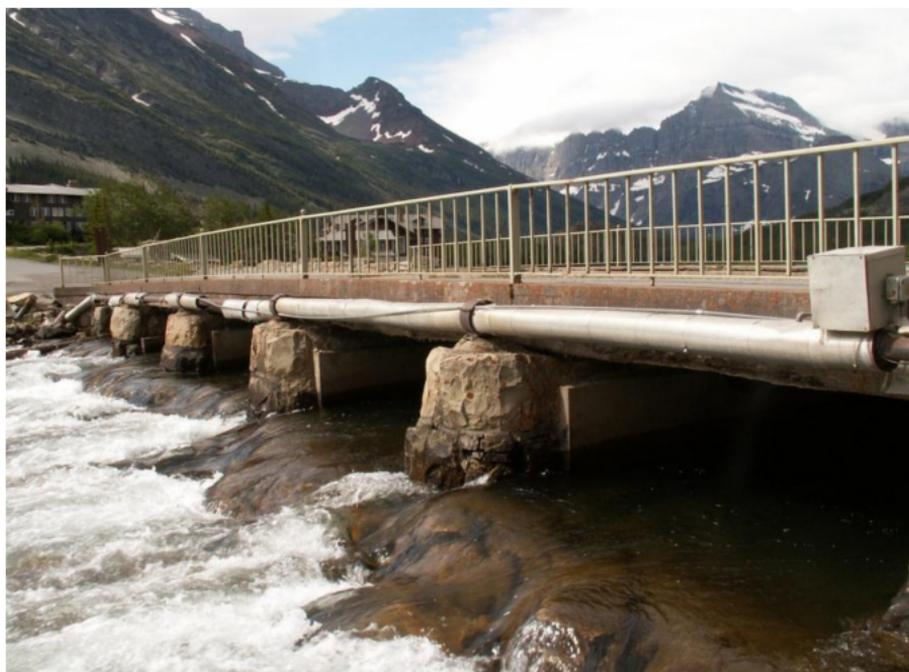
The Swiftcurrent Bridge prior to its replacement, showing the non-code-compliant utility chase.

Other concerns were the severely deteriorated concrete curb and sidewalks, loose or missing stone masonry, and the not-to-code suspended utility conduits and multiple lines of flexible cable/wiring alongside the bridge's deck and encased within the sidewalks.

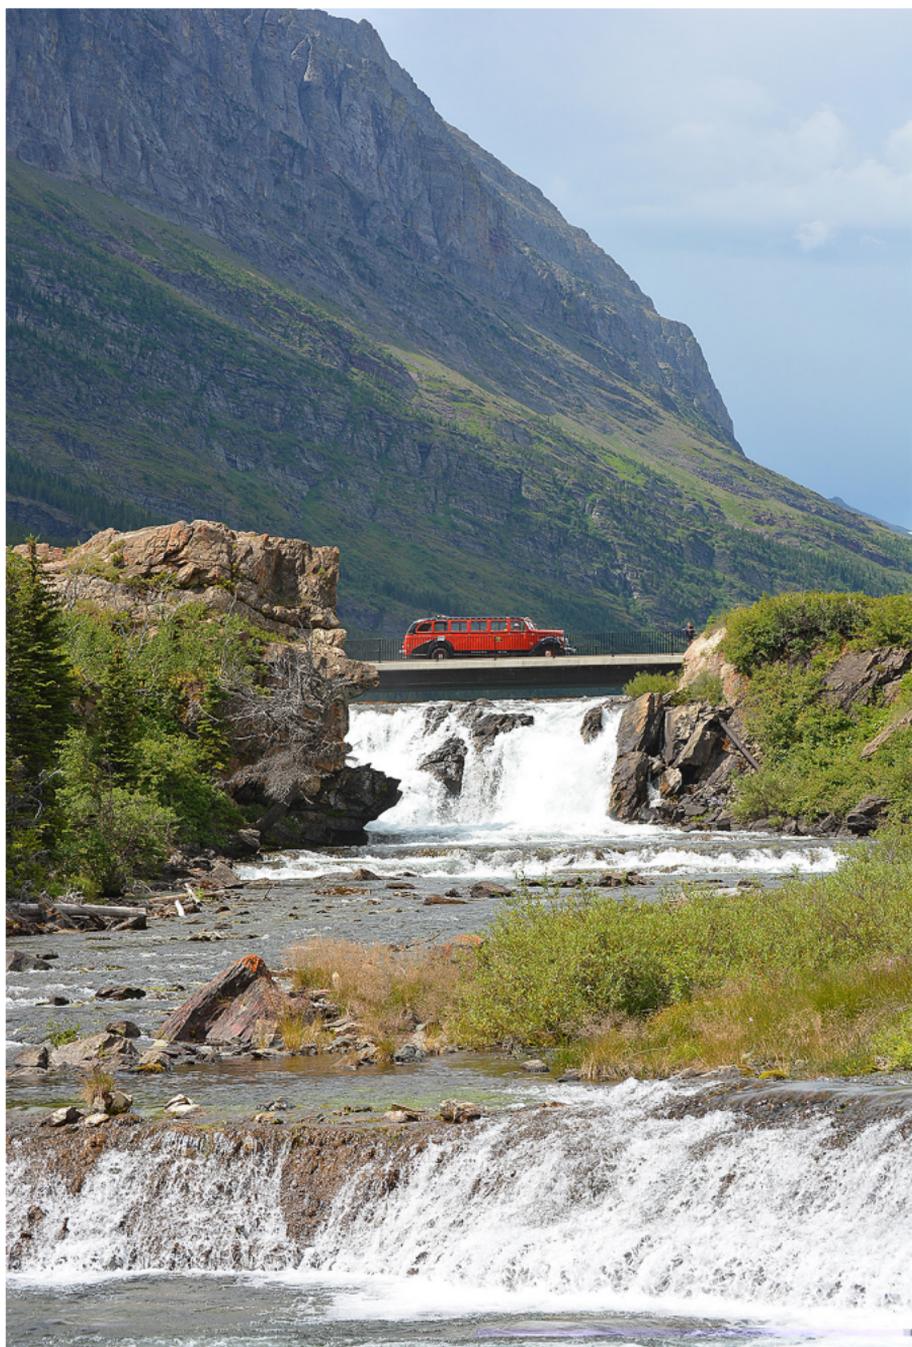
The Swiftcurrent River flows under the reconstructed bridge, downstream from Swiftcurrent Lake. Both the original and new bridge designs sought to lessen the appearance of the bridge as a dam on the river. (NPS photo by Gary MacFadden)
